MARYLAND HISTORICAL TRUST

INVENTORY FORM FOR STATE HISTORIC SITES SURVEY

CT-355 M7+. Harmony Meth. Church

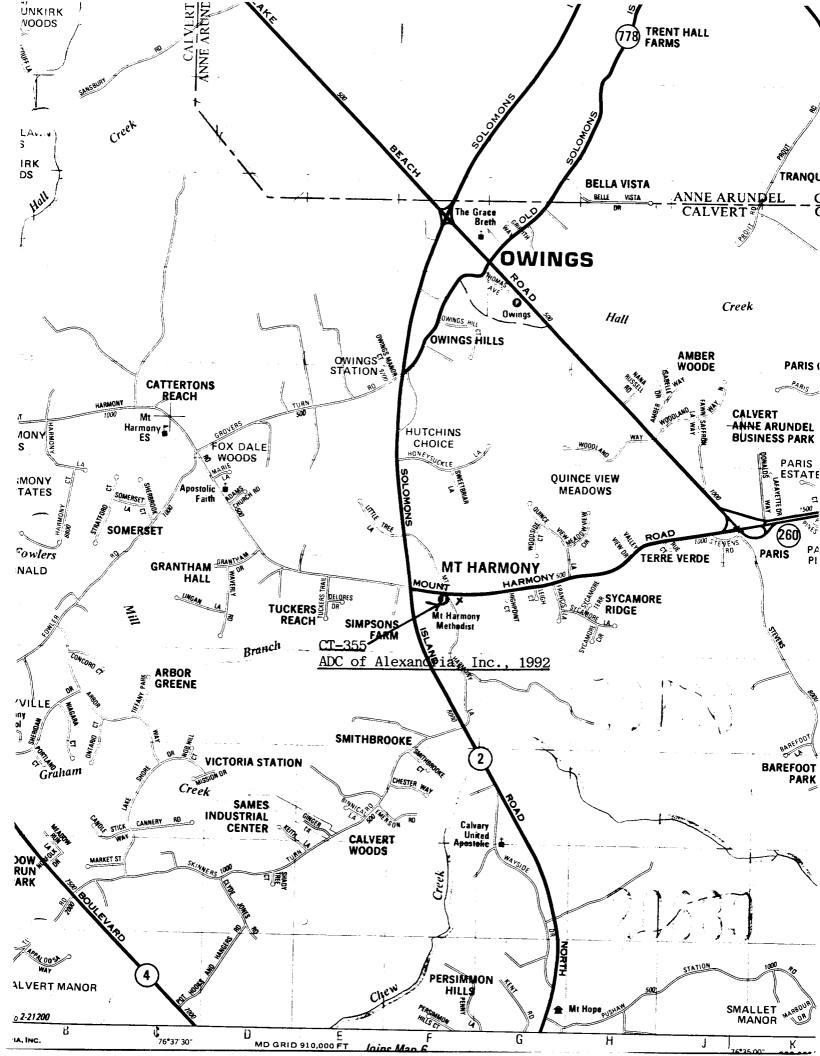
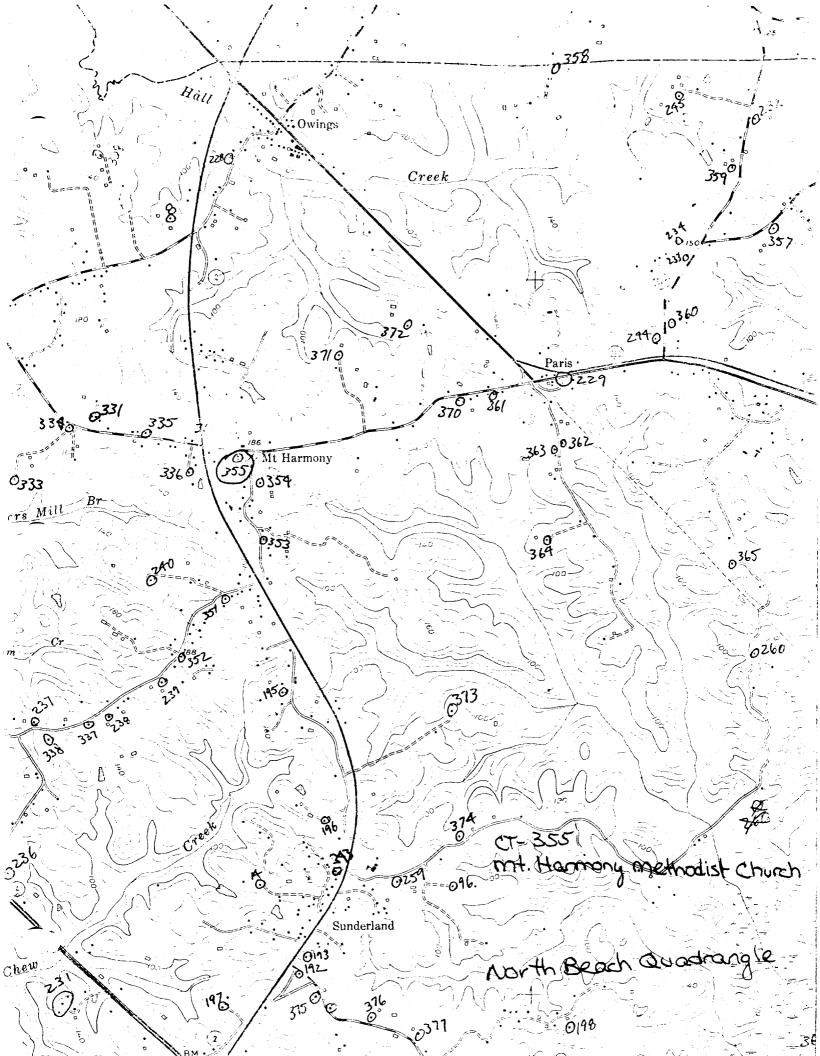
Mt. Harmony Methodist Church is a one story L-shaped frame building with a total of six bays at the facade. There is a projecting entrance and bell tower topped with a multi-sided steeple.

The walls are sleathed with narrow grage aluminum siding and rest on rockfaced concrete block foundations. All openings have a gothic arch with most windows having stained glass.

Brick flues are located in the angle of the ell and at the northeast corner of the building. The roof is sheathed with pressed metal shingles.

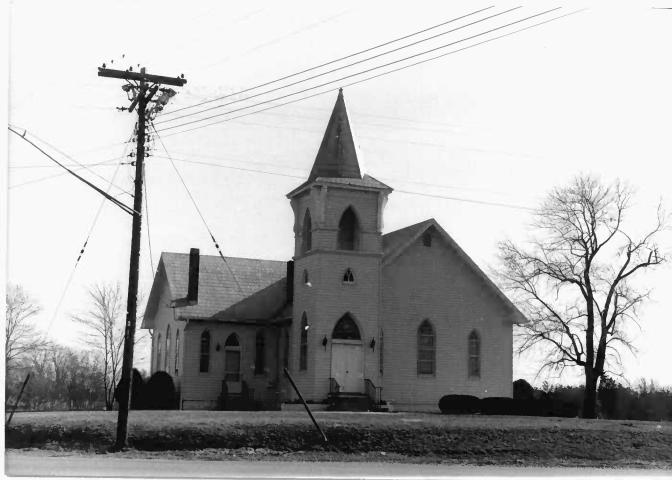
CT-355 Mt. Harmony Methodist Church Calvert County Merry Stinson

N & E elevations
